Act 72 School Facilities Assessment Reports

**AGENCY OF EDUCATION AND BUREAU VERITAS
TECHNICAL ASSESSMENTS (BVTA)**

FACILITY CONDITION ASSESSMENT

BINGHAM MEMORIAL SCHOOL - MAIN BUILDING

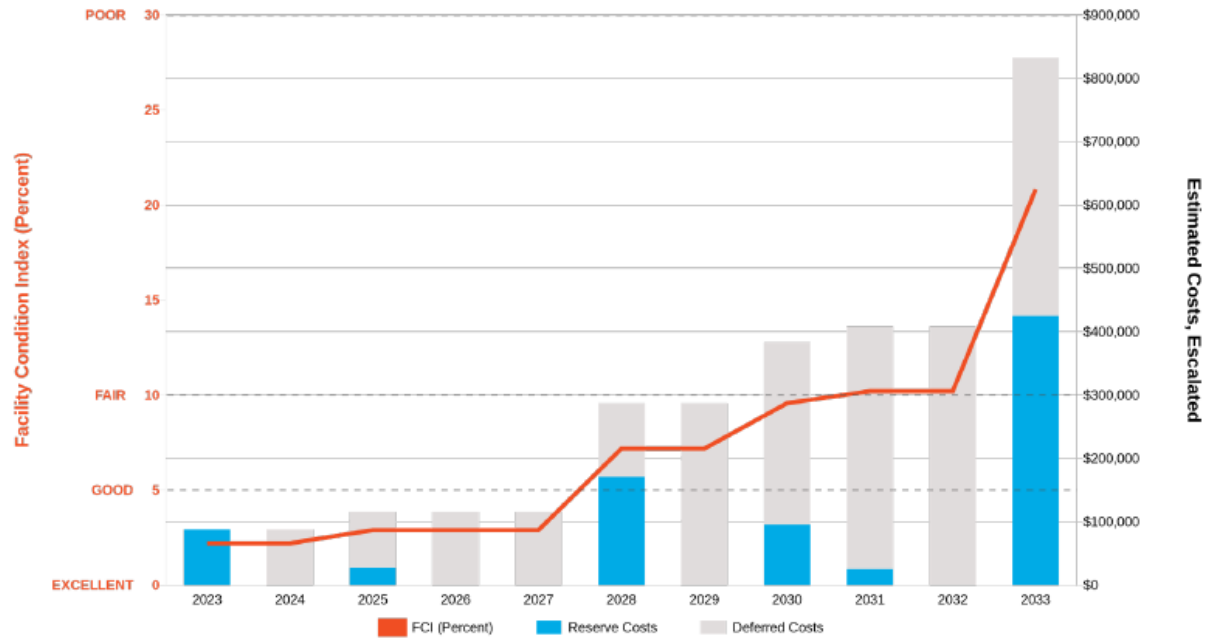
Needs by Year with Unaddressed FCI Over Time

Replacement Value: \$4,000,000.00

Inflation Rate: 3%

Average Needs (per year - over next 10 years): \$75,719.00
